Hartley, J. W., Tse, G., Kratz, J., Ward, C., & Partridge, I. K. (2016). Column Interaction in Tufted Sandwich Structures Under Edgewise Loading. In *ECCM17 - 17th European Conference on Composite Materials: Munich, German, 26-30 June 2016*

# COLUMN INTERACTION IN TUFTED SANDWICH STRUCTURES UNDER EDGEWISE LOADING

**Keywords:** 3-Dimensional Reinforcement, Sandwich, Mechanical Testing, Tufting

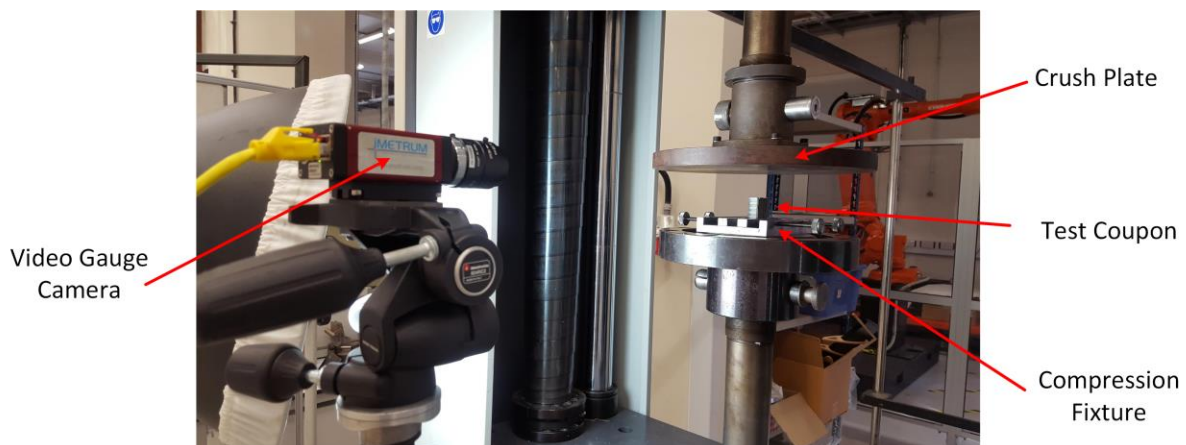
Testing was carried out under quasi-static loading conditions using a Zwick 1466 test machine. Coupons were clamped at the base within an end support fixture, and positioned at the centre of the loading plates, to ensure failure occurred at the free end of the coupon. Coupons were aligned such that the long edge was parallel to the crushing direction, with the polished face exposed for tracking. A displacement control program was used to provide a constant quasi-static crushing rate of 2 mm/min. Testing was terminated after crushing had reached the final tuft before the fixture. A total of 3 coupons were tested per configuration. An Imetrum<sup>®</sup> video gauge system was used to track the movement of the tuft columns at the edge of the coupon. This camera system was able to track the movement of individual pixels within an image, thus following the movement of the tufts as the coupon was crushed. White paint marks were placed on each tuft to act as clear tracking points. The system also allowed video playback of test, allowing failure mechanisms to be viewed and identified.

**Figure 3.** Test setup.
